# Cavitation on small craft propellers and its contribution to underwater radiated noise

**Abstract:** *Cavitation is a major contributor to underwater radiated noise (URN) from commercial ships but less is known about the dynamics, inception speed, and contribution of cavitation to URN for small vessels. Small vessels often use propellers located very close to the free surface and which turn at high speeds. This means that the cavitation dynamics are likely to be different from those on larger ships. Additionally, many small vessels are powered by internal combustion outboard engines, which typically expel exhaust gases through the hub, leading to a bubbly hub vortex. In this work, acoustic data from small boat trials are presented alongside underwater camera footage to show how cavitation develops on small high speed propellers and how it contributes to the acoustic signature. The results show that the cavitation inception speeds are typically 5-6 knots, and this is accompanied by a sharp rise in noise across a broad frequency range. Visual footage shows that tip vortex cavitation (TVC) dominates at low speeds. Results are also presented that provide insights into how the materi

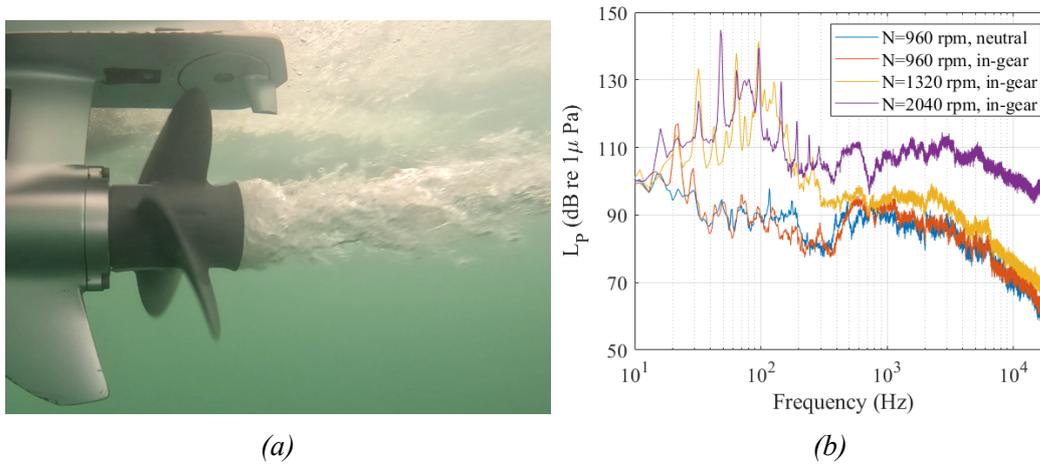
Figure 1: (a) hub gases being expelled through the hub of the 5 m RIB at 4 knots. (b) narrow-band spectra for the vessel moored up with the engine running at different speeds.

ICE outboard motors typically have two exhausts: one above the waterline and one in the propeller hub. When idling or at very low speeds, gases are expelled through a port above the waterline. As the speed increases (usually at around 3-4 knots), the increased pressure in the engine and the reduced pressure in the hub vortex results in the gases being expelled through the hub. This is shown in Figure 1(a) which is for the 5 m RIB travelling at 4 knots.

This has two important consequences for underwater noise. Firstly, it results in the hub being relatively large as a proportion of the overall propeller diameter. Thus, for a given diameter, there is less area providing thrust which increases the load per unit area and hence the propensity for the propeller to cavitate. Secondly, the expulsion of gas into the low pressure hub vortex core creates noise. To determine how this contributes to the acoustic signature, trials have been carried out with the vessel tied alongside and doing a bollard pull. This has been done to eliminate noise from spray and other hydrodynamic sources. The engine was run at a series of different speeds and a hydrophone located 2 m away from the propeller recorded the sound. Narrowband spectra are shown in Figure 1(b) for the vessel when idling and at two higher engine

speeds. When idling and not in gear, the noise levels are only very slightly above background noise. When idling but in gear, tonal components at the engine firing rate and propeller rate are observed but no other significant changes are observed. At 1320 RPM, the exhaust gases are expelled through the hub but no cavitation is observed. In addition to an increase in tonal components at the engine and propeller rates, there is a pronounced low-frequency broadband hump from 10 to 300 Hz. At 2040 RPM, the low frequency noise levels are similar, but there is a significant increase in broadband levels at mid and high frequencies. The camera footage shows that cavitation is present at this speed and so this noise is likely dominated by cavitation collapse. From this, we can deduce that the exhaust gases result in a low frequency broadband hump in the acoustic spectrum.

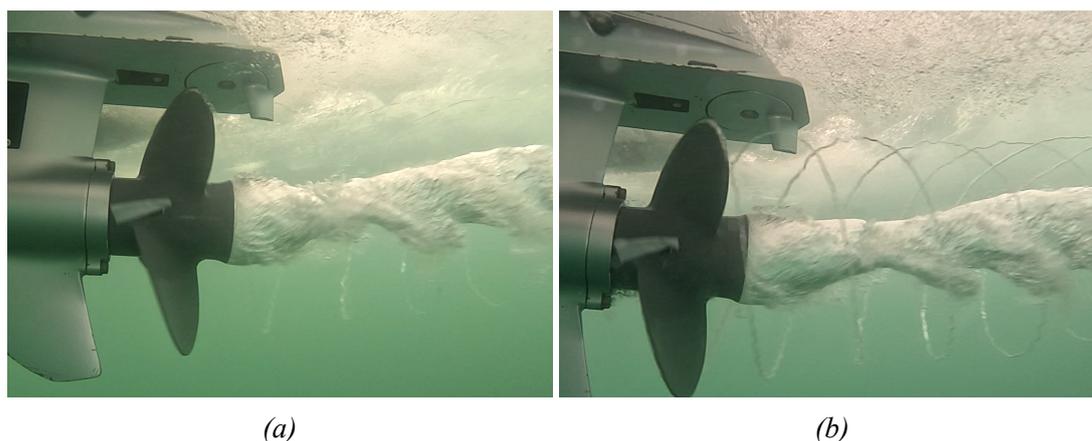
Figure 2: Tip vortex cavitation on the 5 m RIB at (a) 5 knots and (b) 6 knots.

TVC emerges on the propeller on the 5 m RIB consistently at 5 knots. At 6 knots, fully developed TVC is observed, with cavitating tip vortices propagating several propeller diameters downstream before they break up and collapse. Images of the cavitation pattern at 5 and 6 knots are shown in Figure 2. The onset and development of cavitation on the 6 m RIB follows a similar pattern, but this occurs at a slightly higher speed, with TVC first appearing at 6 knots but not fully developing until around 8 knots. This is partly because the 6 m RIB uses a larger propeller that operates at a lower speed. At 5 knots, the cavitation number calculated using the propeller rotation rate is  $\sigma_n = 0.76$  for the 5 m RIB and  $\sigma_n = 1.32$  for the 6 m RIB. By 6 knots, this has reduced to  $\sigma_n = 0.90$  for the 6 m RIB, and so cavitation first occurs at a similar cavitation number for the two vessels. Narrowband spectra for the two vessels are shown in Figure 3 at 6 and 10 knots. For the 5 m RIB at 6 knots, the blade rate is very pronounced and there is a broadband hump centred around 400 Hz. This is characteristic of TVC noise [12]. This is far less prominent for the 6 m RIB due to the later emergence of cavitation. The increase in high frequency noise on the 6 m RIB going from 6 to 10 knots coincides with the increasing levels of cavitation. At 10 knots, a broadband hump is visible for both vessels but is far less prominent

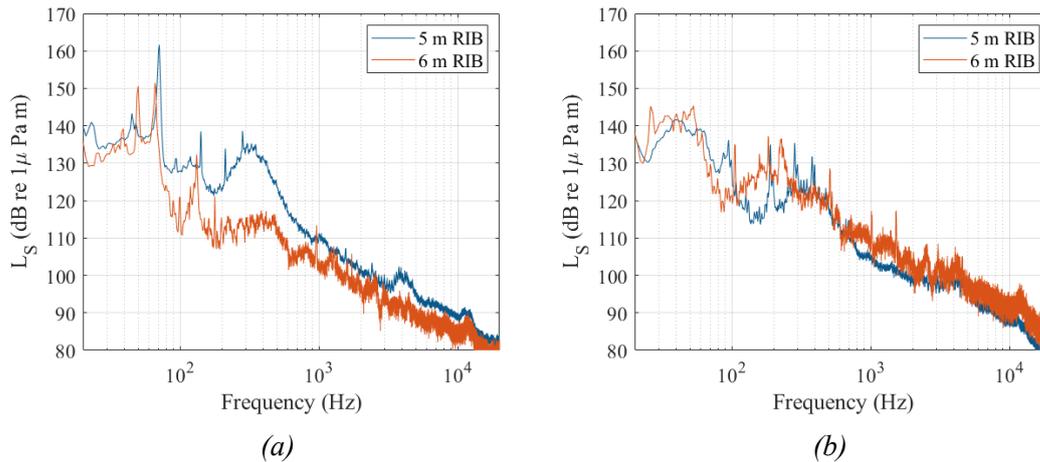
Figure 3: Narrowband source levels for the two vessels at (a) 6 knots and (b) 10 knots

and the broadband noise levels are actually lower for the 5 m RIB at 10 knots than at 6 knots. It was not possible to obtain good camera footage at 10 knots due to the large number of bubbles being entrained in the flow. It may therefore be that these bubbles are attenuating some of the noise and this may partly explain the lower noise levels. It may also be that higher turbulence levels disrupt the formation of the tip vortices. Changes in propeller loading also occur over this speed range, as noted in [9]. Further research is needed to better understand the mechanisms here, as the results show that speeding up can be beneficial from a noise perspective, which is generally not the case for larger vessels.

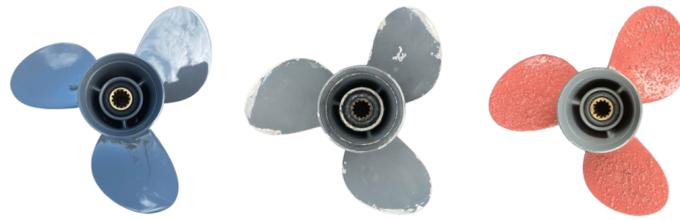
Figure 4: The clean (left), damaged (centre), and artificially roughened (right) propellers.

However when TVC is present, studies have shown that roughness at the tip can effectively reduce TVC by modifying the roll-up process and leading to a weaker vortex strength [13, 14]. To provide further insights into how roughness and damage/wear affects propeller noise levels, trials have been conducted at 6 and 10 knots using a clean, slightly damaged, and an artificially roughened propeller. This was roughened by applying 1-2 mm elements randomly across the blade surfaces. The details of the material state of these propellers are given in [10] and photographs are shown in Figure 4. The narrowband source levels are shown in Figure 5 and this confirms the findings of the aforementioned studies. Even a very moderate level of surface wear or roughness can be effective at alleviating TVC. The propeller still cavitates at 6 knots, as shown in Figure 5(b), but it is far more fragmented and does not extend as far downstream. As a result, the noise due to collapse (typically high frequency) is the same but the lower frequency noise associated with the oscillating cavity volumes is significantly reduced. Further research is needed to understand the minimum levels of roughness required to achieve this and to determine whether this effect is observed over a wider range of operating conditions.

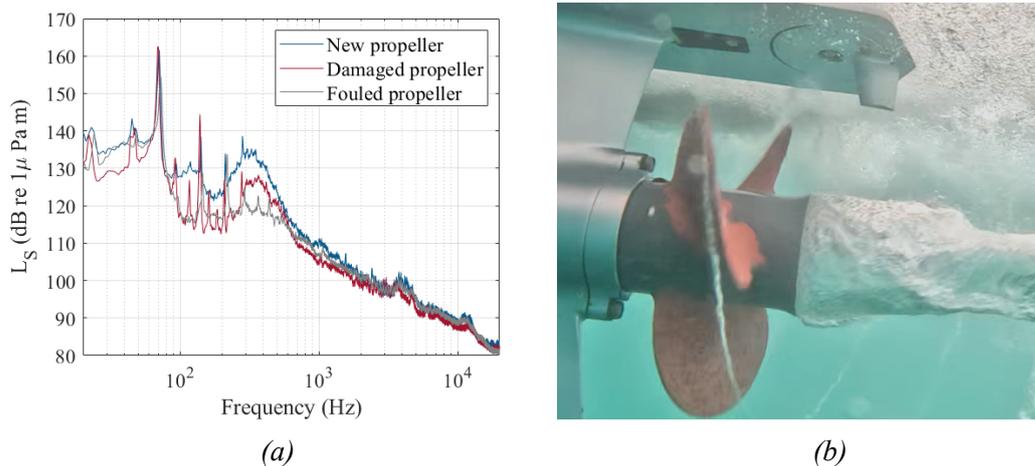
Figure 5: (a) Narrowband spectra for the 5 m RIB at 6 knots with the three propellers. (b) Cavitation on the roughened propeller at 6 knots. Adapted from [10].
